# WSRB CASUALTY REPORT

<b>Owner:</b> Speciality Investments LLC			<b>Policy #:</b> CLP123456
<b>Address:</b> 16420 NE 128th Ave, Centertown WA 98000			
<b>Survey Date:</b> 10/9/2014	<b>Contact:</b> Lars Phant	<b>Phone:</b> 425-555-2993	
<b>Surveyed By:</b> T. Adefris	<b>Interviewed:</b> Lars Phant	<b>Phone:</b> 425-555-2993

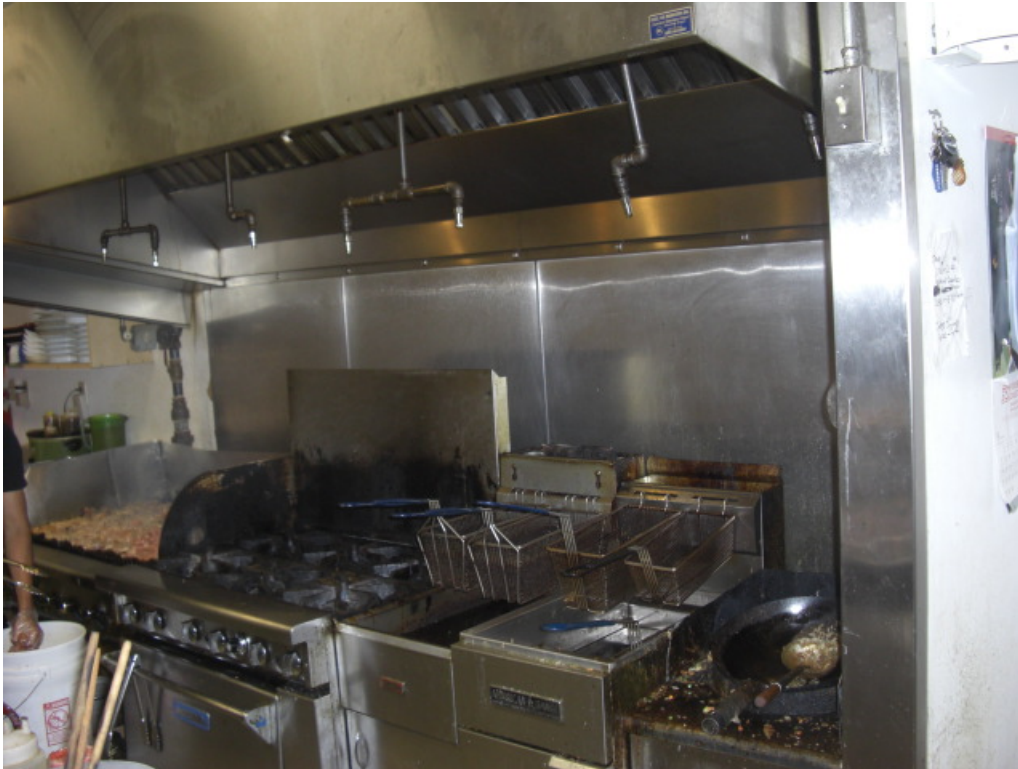
Yoshabi Teriyaki kitchen

Building No. 1 has a Thai Restaurant, Yoshabi Teriyaki, whose kitchen use range, wok, broiler and 2 deep fat fryers. All appliances are under exhaust hood & vent system and are protected by a UL-300 suppression system that was last serviced in May 2014. Exhaust hood and vent were last steam cleaned in May 2014. Splash guard is needed between deep fat fryer and adjacent open flame burners.

1. Appliance placement in Yosahabi Teriyaki is not all per NFPA 96 since deep fat fryer do not have an 18-inch clearance from open flame. Splash guard is needed between deep fat fryer and adjacent open flame burners.
2. The area behind Building-2, Behind Superstar Nails, should be cleared of vegetation and discarded items to discourage unauthorized trespassing and dumping.
3. Establish a monthly pest control contract with a contractor that specializes in the food service industry.

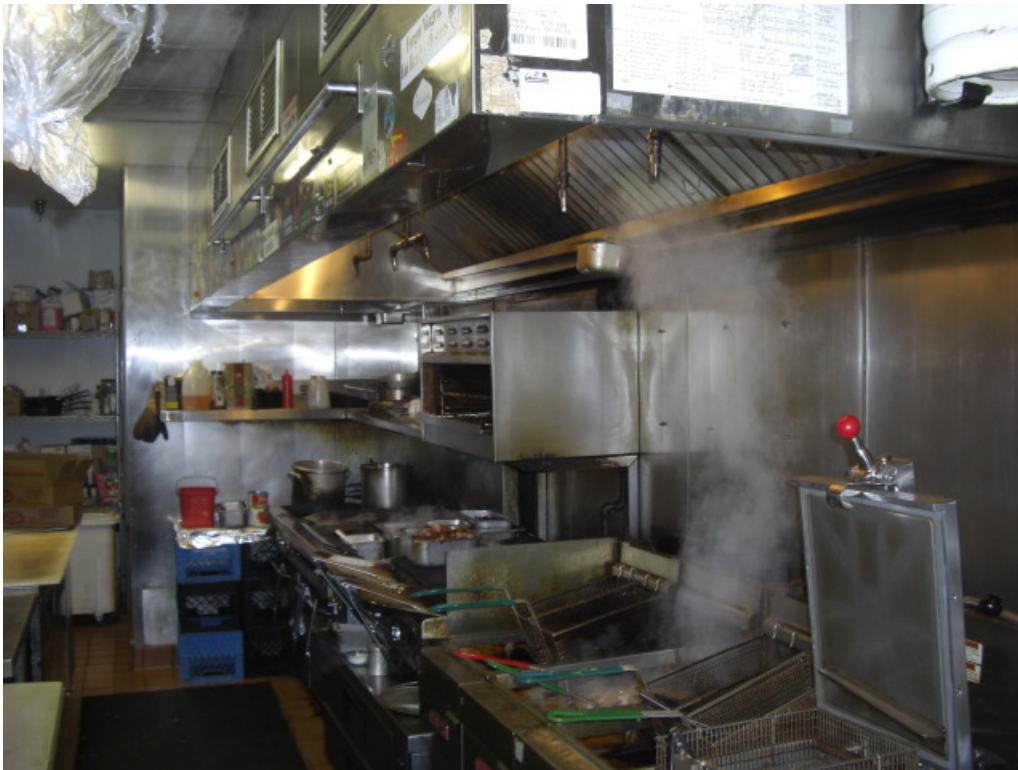
Hoofers Bar & Grill - Kitchen

Building No. 2 has a restaurant, Hoofers Bar & Grill, whose full kitchen use range, broiler, salamander and 5 deep fat fryers. All appliances are under exhaust hood & vent system and are protected by a UL-300 suppression system that was last serviced in September 2014. Exhaust hood and vent were last steam cleaned in May 2014.

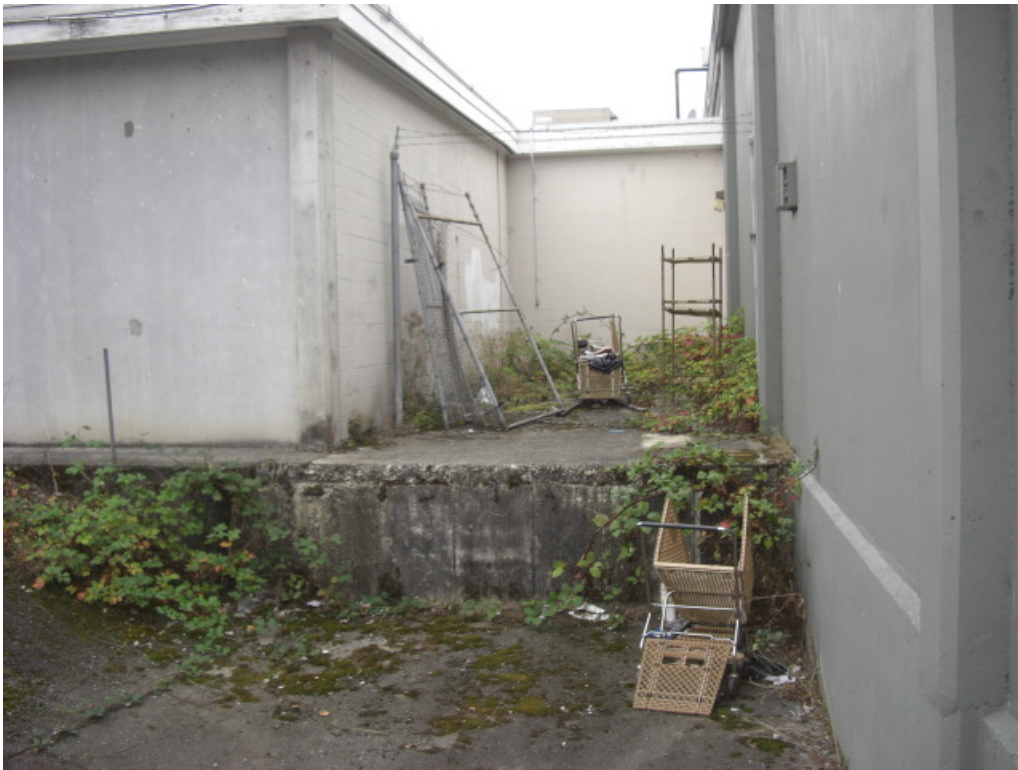
Garbage and recycling areas appear well maintained; trash is collected by the city once a week. There is an area, behind B uilding-2, with grown vegetation and containing a few discarded items including shopping carts.

Rear close up; behind Superstar Nails - needing clean up
